## F-111 Adhesive Bonded Repairs Assessment Program - Progress Report 1: Analysis of FM300 Repairs

*Eudora S. Y. Yeo and Andrew N. Rider*

DSTO-TR-2849

# F-111 Adhesive Bonded Repairs Assessment Program - Progress Report 1: Analysis of FM300 Repairs

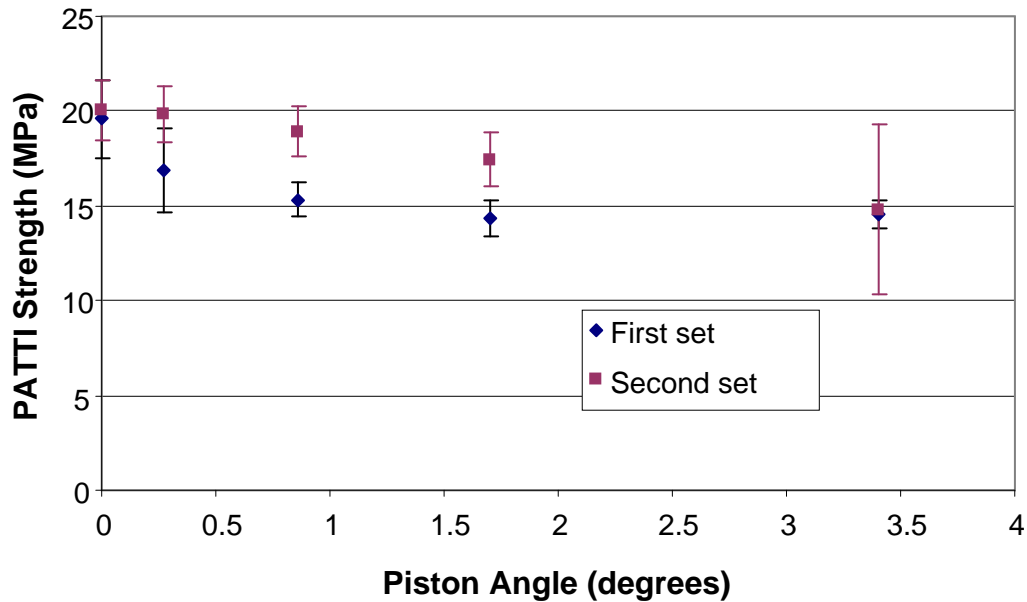
Figure 4 shows the relationship between PATTI strength and the angle of piston to the test surface. Stubs in the first set used staged adhesive. At a 5.1° piston angle, the gasket popped out of the piston before sufficient pressurisation was reached to achieve stub failure. It is unlikely that field experiments would have been able to undertake any tests with a piston angle much greater than 3.4°. If 3.4° is taken as the maximum practical angle that the piston could have achieved, then it appears that when the substrate thickness is 3.2 mm, a pristine stub could fail at loads as low as 15 MPa due to potential off-angle loading effects of the piston. It is also noteworthy that as the piston misalignment increases, the degree of variation in the measured PATTI strength increases significantly. If this variation is considered, then values approaching 10 MPa are possible in the worst case for a repair which had not experienced any significant strength degradation.

The failure surfaces of stubs prepared with unstaged adhesive (Figure 5) showed high levels of bondline porosity. General observation of a large number of stubs from tested repairs indicated that bondline porosity was prevalent and could be quite high. The porosity is expected given most repairs were conducted using vacuum bag pressurisation. The results in Figure 4 indicate that porosity may not have any effect on the strength of an

Figure 4 Relationship between PATTI strength and the angle of piston to the test surface. Stubs in the first set used staged adhesive.

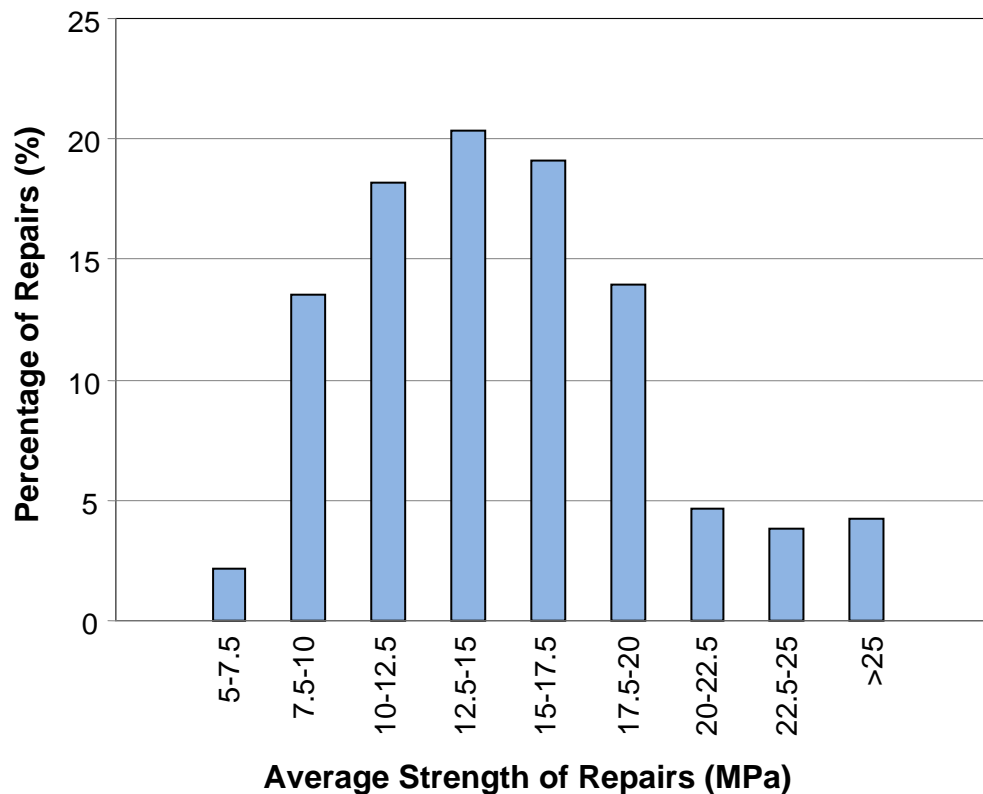
Figure 6 The distribution of repair strength for the 236 FM300 repairs tested during the bonded repair trial

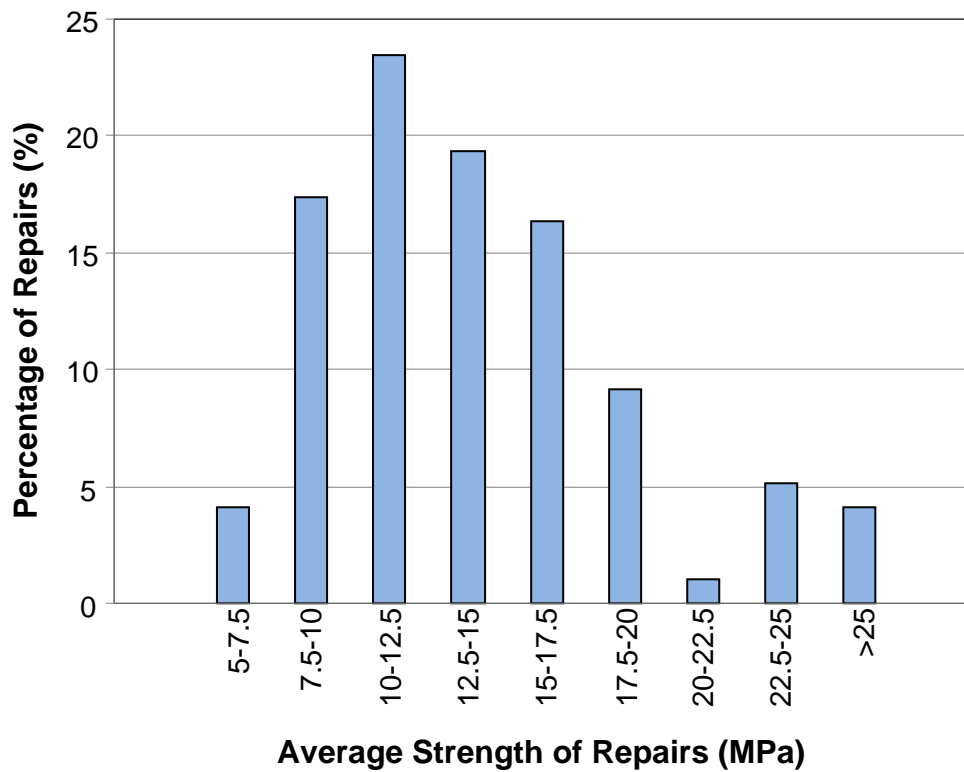
Figure 7 shows the strength distribution of the bonded repairs that had a traceable service history, with repairs based on a single test removed. The overall distribution in strength is similar to the total population set and provides some confidence that trends observed for the smaller dataset with recorded history would be representative of a significantly larger repair population.

Figure 7 The distribution of repair strength of FM300 repairs in which records detailing the repair application processes, dates of application and service history are available. There are 98 FM300 repairs.

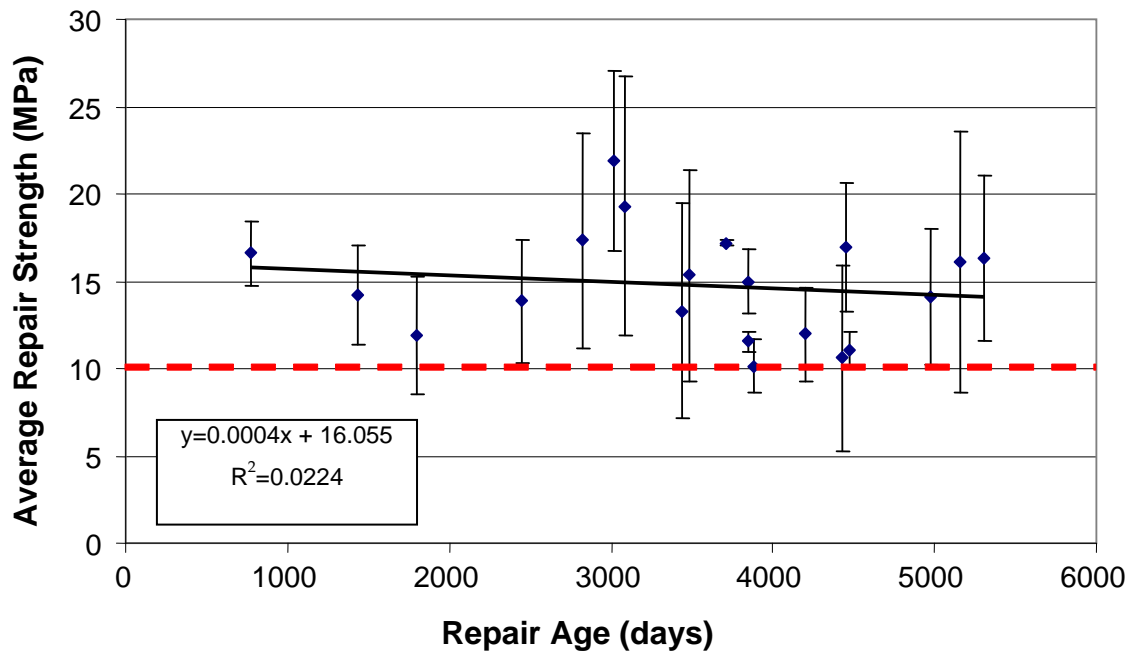
The initial analysis of the bonded repairs examined if a correlation existed with the average repair strength and the repair age (Figure 10). The repair age represents the total accumulated time since the repair was applied to the time the repair was tested. There is no correlation in strength with repair age as indicated by the wide distributions of strength that exist for the repairs ranging between 500 and 6000 days or around 1.5 to 16 years. The extent of variation for discrete repair ages is greater than the difference in the average value for nearly all the data.

Figure 10 The average repair strength measured as a function of total age of the repair where the error bars represent the 95% confidence interval for all repairs measured with the same lifetime. The broken red line represents the lower limit expected for undegraded bonds accounting for possible geometrical variations in loading.

The results from both Figure 10 and Figure 11 suggest that it is equally likely that a repair randomly measured for strength over a period of at least 6000 days of total life or 1600 hours flight time or both will have an average strength around 15 MPa with a 95% confidence interval around  $\pm 4$  MPa. These initial results are quite encouraging as they show that with 95% confidence, a minimum strength around 11 MPa would be expected for the total lifetime of the repairs examined. This is above the 10 MPa lower limit which is possible when accounting for variation in bondline strength that would simply be due to geometrical loading effects, discussed above in Section 4.1. Clearly, the average results also contain individual repairs where the strength was below 10 MPa and further analysis of these repairs is undertaken in following sections.

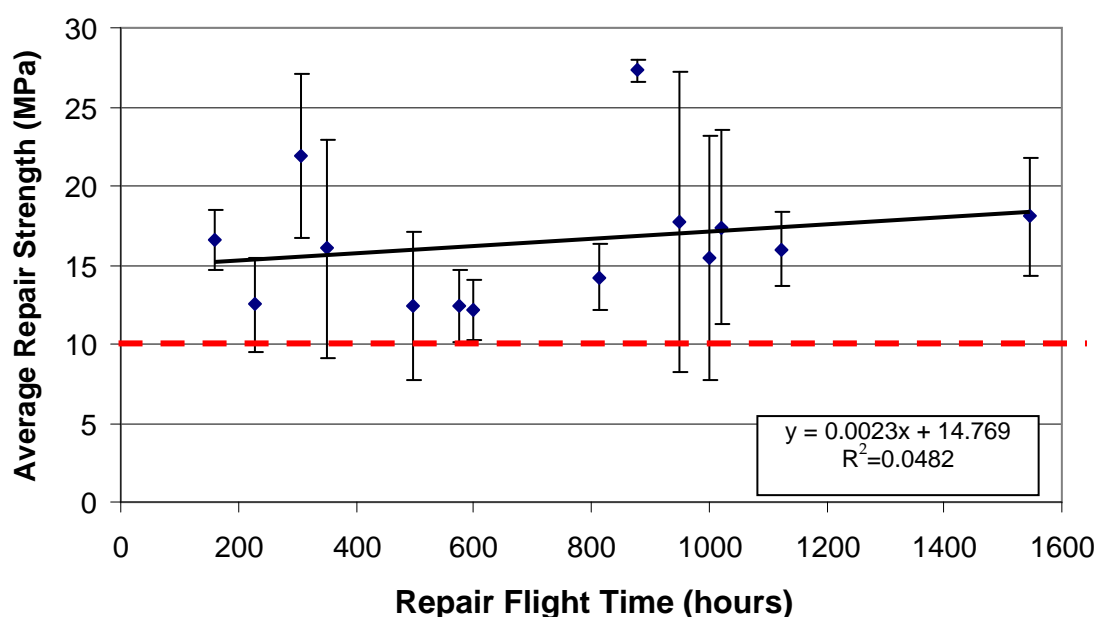
Figure 11 indicates the average repair strength as a function of accumulated flight hours. The data is similar to Figure 10 and shows that the strength does not depend on the accumulated flight hours, with the variation of repair strength at discrete times being typically greater than the average strength over period between 100 and 1600 hours.

Figure 11 Correlation between flight hours experienced by each repair and average repair strength, where the error bars represent the 95% confidence interval for all repairs measured with the same accumulated flight hours. The broken red line represents the lower limit expected for undegraded bonds accounting for possible geometrical variations in loading.

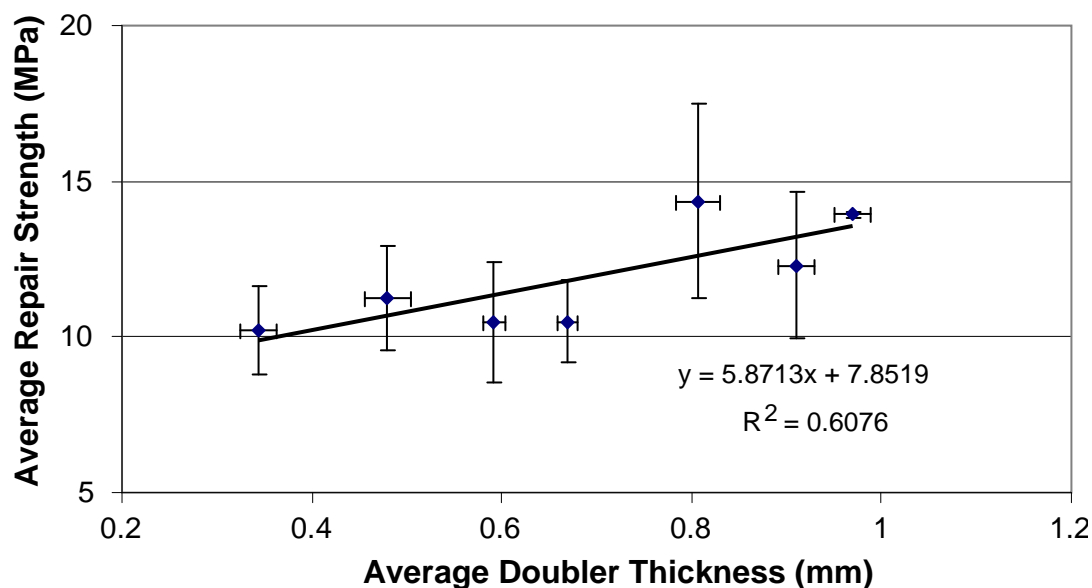
Section 4.1.2 demonstrated that the stiffness of the repaired structure can affect the measured PATTI strength. Typically, the repair doubler is the same thickness as the aircraft skin on which it is applied, although this is not always true as aircraft skins tend to increase in thickness towards the edges of panels. The doubler thicknesses of selected repairs were consequently measured physically and optically and compared with the measured strength, shown in Figure 12, to establish if there was a tendency for thicker doublers, and therefore thicker substrates, to provide higher strength. The results show that, allowing for the variation in strength data for skin thicknesses of similar values, there is a direct correlation. As there is considerable variation in individual repair strengths at given thicknesses, the correlation is not strong, but certainly shows that skin thickness influences the measured strength. This finding supports the general assumption that geometrical loading effects experienced during PATTI testing could lead to minimum strength values for undegraded bonds approaching 10 MPa.

Figure 12 The influence of average repair strength as a function of repair doubler thickness

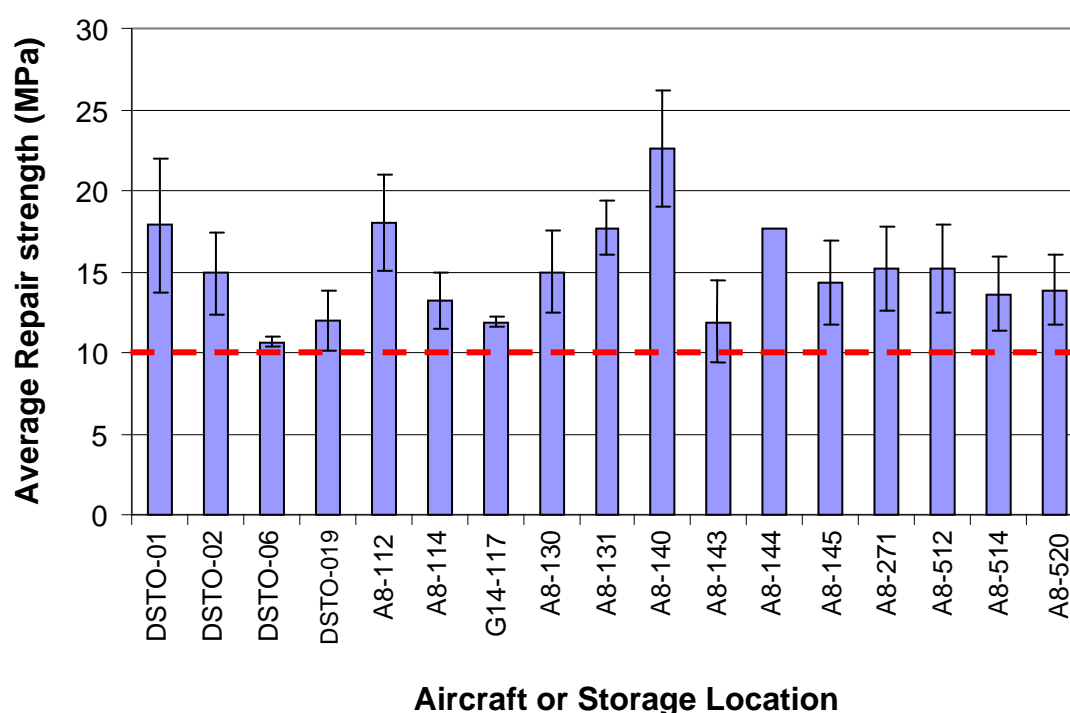
After the individual test stubs detailed in Table 2 were excluded, repairs with only one stub were also removed from the data set, as one data point per repair does not provide a significant statistical distribution. Additionally, as discussed above, as the repair area being interrogated is at the very edge of the repair, the strength of repairs with small and large doublers should be equivalent as they will have been exposed to moisture for equivalent times. Consequently, the data set of FM300 repairs reduced to 163 repairs from the original 236. Figure 13 shows the distribution of average repair strength in the modified data set for each aircraft or from specific storage locations in which DSTO had recovered the paperwork, denoted as DSTO-01, -02, 06. It can be seen that only A8-143 has repairs where the spread in strength, which is represented by the 95% confidence limit error bars, drops below the 10 MPa limit.

Figure 13 Average repair strength for each aircraft examined or for components recovered from storage locations. The dataset has stub results reported in Table 2 and repairs with only single measurements removed. The broken red line represents the lower limit expected for undegraded bonds accounting for possible geometrical variations in loading.

Specifically, repair number five from A8-143 had 10 pull stub tests carried out and 9 of the 10 tests from this repair had strengths below 10 MPa. The low strength repair location on panel 3208 was identified in Figure 9. Table 3 shows a detailed analysis of each of the pull-stub tests from repair 5 on A8-143. It was noted that most stubs exhibited higher levels of voiding than were previously observed on average strength stubs and that some evidence of adhesion failure was noted, shown in Figure 14. The strength below 10 MPa is believed to represent a reduction in strength from the typically applied repair, with high voiding levels suggesting deficiency in the application process, whereby either high humidity

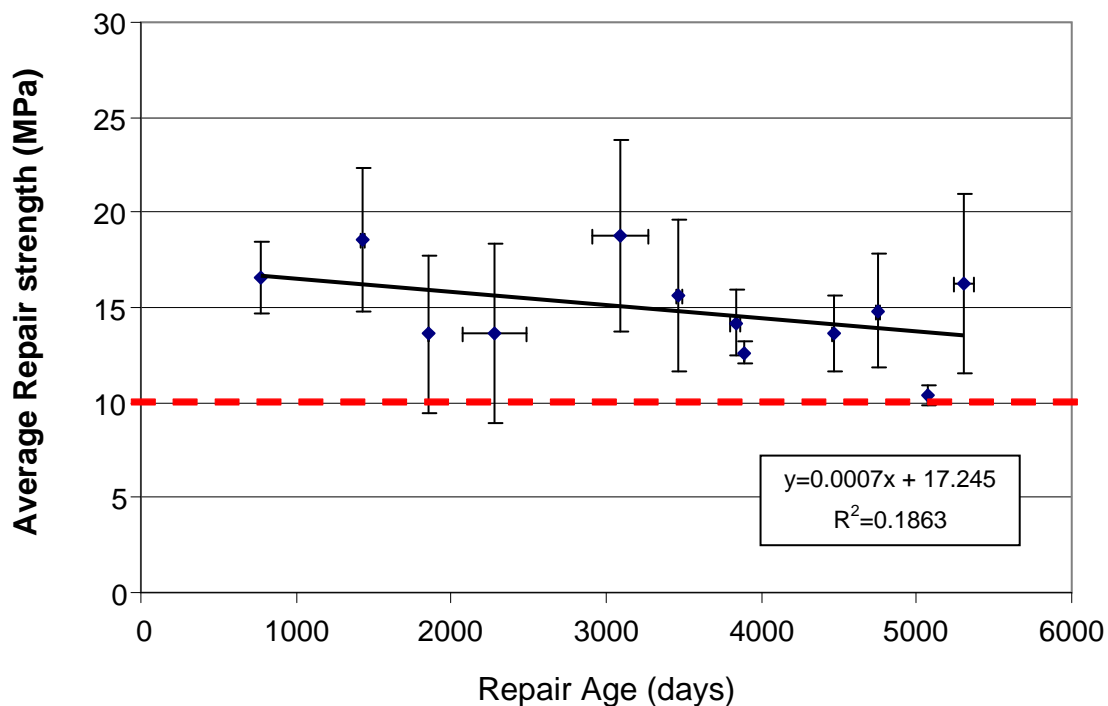
Figure 15 shows the average repair strength as a function of total repair age for the modified dataset where individual stub results from Table 2 were removed from the original dataset, as well as any repairs where only a single adhesion stub was tested. The results show that the average repair strength across the 15 years is around 15 MPa with a 95% confidence limit of  $\pm 3$  MPa. The confidence limit is only marginally lower than the unprocessed data but suggests that, if accounting for anomalous results and statistically limited data, the lowest probable strength would be 12 MPa. When accounting for the weak trend in data, which suggests some reduction of bond strength with time, the likely strength of a new adhesive bonded repair would be approximately 17 MPa, and after more than 15 years exposure the strength could drop by only 12% on average. The data provides an encouraging indication that the strength of the bonded repairs does not appear to be significantly affected over a considerable period of time. Generally, the spread in data appears to be relatively consistent over the period of the analysis, which suggests that this variability in strength measurements is inherent in the intrinsic strength of the repairs, as applied, as well as the measurement techniques used. It should also be noted that the data filtering applied has reduced the original dataset from 236 to 163 repairs and then of those repairs only 62 had recorded application dates, but given the similar trends observed in Figure 10 and Figure 15, there is some confidence that the overall analysis is representative of a larger dataset.

Figure 15 The average repair strength as a function of total accumulated time since application, where individual stub results from Table 2 were removed from the original dataset as well as any repairs where only a single adhesion stub was tested. The broken red line represents the lower limit expected for undegraded bonds accounting for possible geometrical variations in loading.

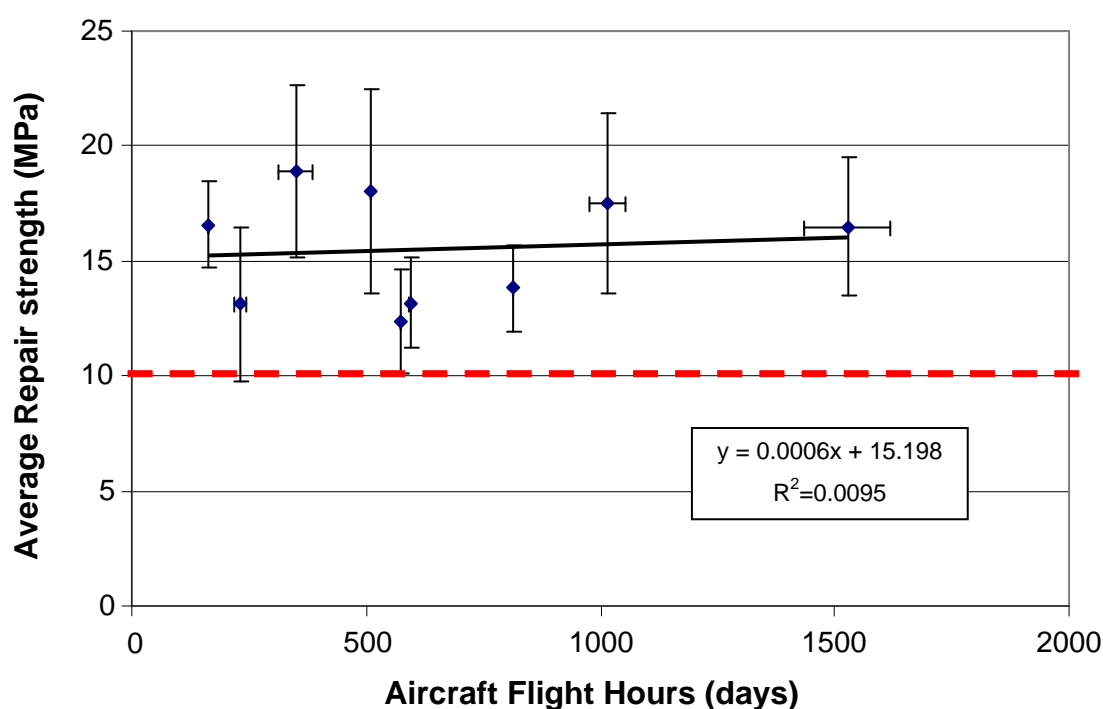
Further analysis of the dataset in Figure 15 examined the trend in repairs where the flight hours was confidently known through review of available paperwork. This reduced the number of repairs further to 43. However, it can be seen that the trend in Figure 16 is similar to Figure 15 and Figure 10, with average repair strengths over the 1500 flight hours of data having similar average values and similar confidence limits. The average strength is 16 MPa with a 95% confidence interval around  $\pm 3$  MPa. No repairs have average strength values below 12 MPa, which provides confidence that flight hours do not significantly affect the strength of the bonded repairs. Similarly, strength variation is relatively similar for the range of times examined, suggesting the variation is inherent in the repairs and measurement techniques used. A8-112 aircraft had one repair, number 29, with an average value of 9.8 MPa corresponding to 224 flight hours. Two stub results at 8.5 and 9.3 MPa showed similar failure surfaces to those described in Table 3, with higher levels of porosity and evidence of adhesion failure. Once again, it appears that the slightly lower strength results recorded for these stubs is a genuine indication of a reduced bond strength from average and is likely due to inadequacies associated with original application. There were no signs of degradation associated with moisture absorption of the bondline.

Figure 16 Only repairs with a traceable service history have been included in this data set. This reduced the number of repairs to 43.

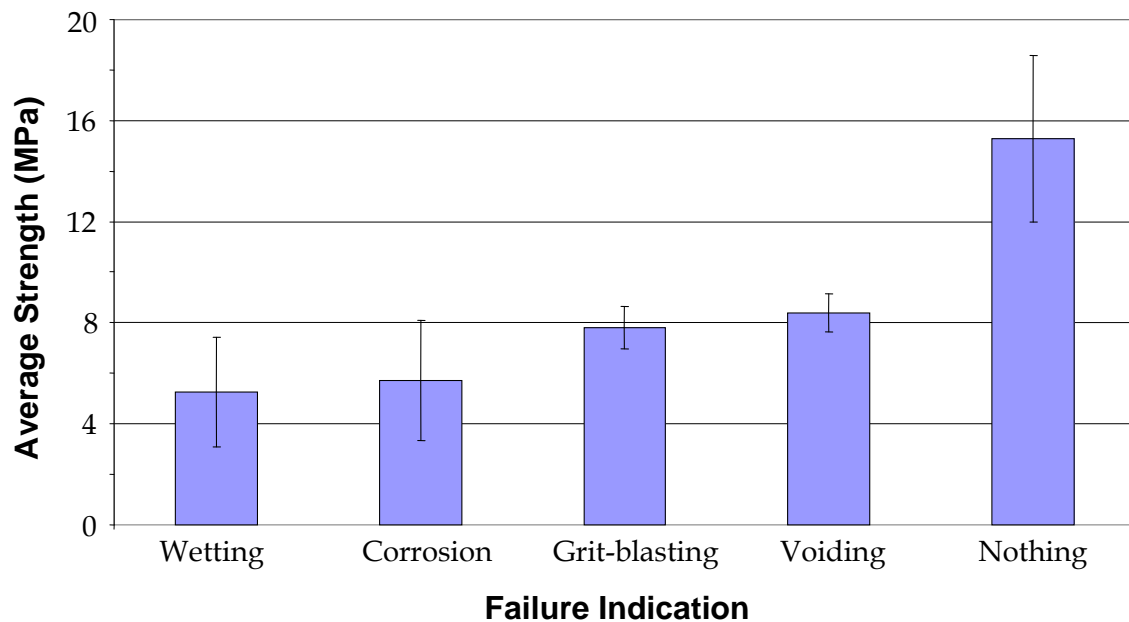
A summary of the failure indications and the average strength associated with each type is provided in Figure 21. The results indicate the average strength for each indication type, with the spread in data shown by error bars, which represent the 95% confidence limits. The plot provides a useful measure of the relative severity of each type of failure with respect to the reduction in the overall stub strength in the locally affected areas. Both corrosion damage and poor adhesive wetting of the aluminium surfaces leads to significant decreases in strength, indicating identification of these defects would have the highest priority in repair inspection and maintenance. The poor grit-blasting also causes reduction in strength, but together with high voiding does not appear to lead to as significant reductions as corrosion and wetting, but would be important to identify in any post repair inspections. Interestingly, the areas of the repair without any indications provided average strengths and deviations that are very similar to the average values determined in Figure 15 and Figure 16. This suggests that average repair strengths for the filtered data represent the significant majority of the total repair areas examined, with degradation in strength being confined to relatively localised regions. Generally, this would imply that no single repair had significant levels of strength reduction associated with long term environmental or service exposure.

Figure 21 Average strength for individual pull-stubs with failure indications categorised according to problems with adhesive wetting (wetting), localised corrosion (corrosion), inadequate grit-blasting (grit-blasting) and high levels of voiding (voiding). The strengths are compared to stubs measured on the same repairs without any indications (nothing).
